Re: Compliance Stormwater Evaluation Inspection
Concrete Supply Co. Greer, South Carolina, Permit SCR005480

U.S. Environmental Protection Agency, Region 4
61 Forsyth Street SW, Atlanta, GA 30303
Water Compliance Inspection Report

CSC Greer ISW 2019
EPA R4 NPDES Inspection Photolog

Inspected 5/29/19

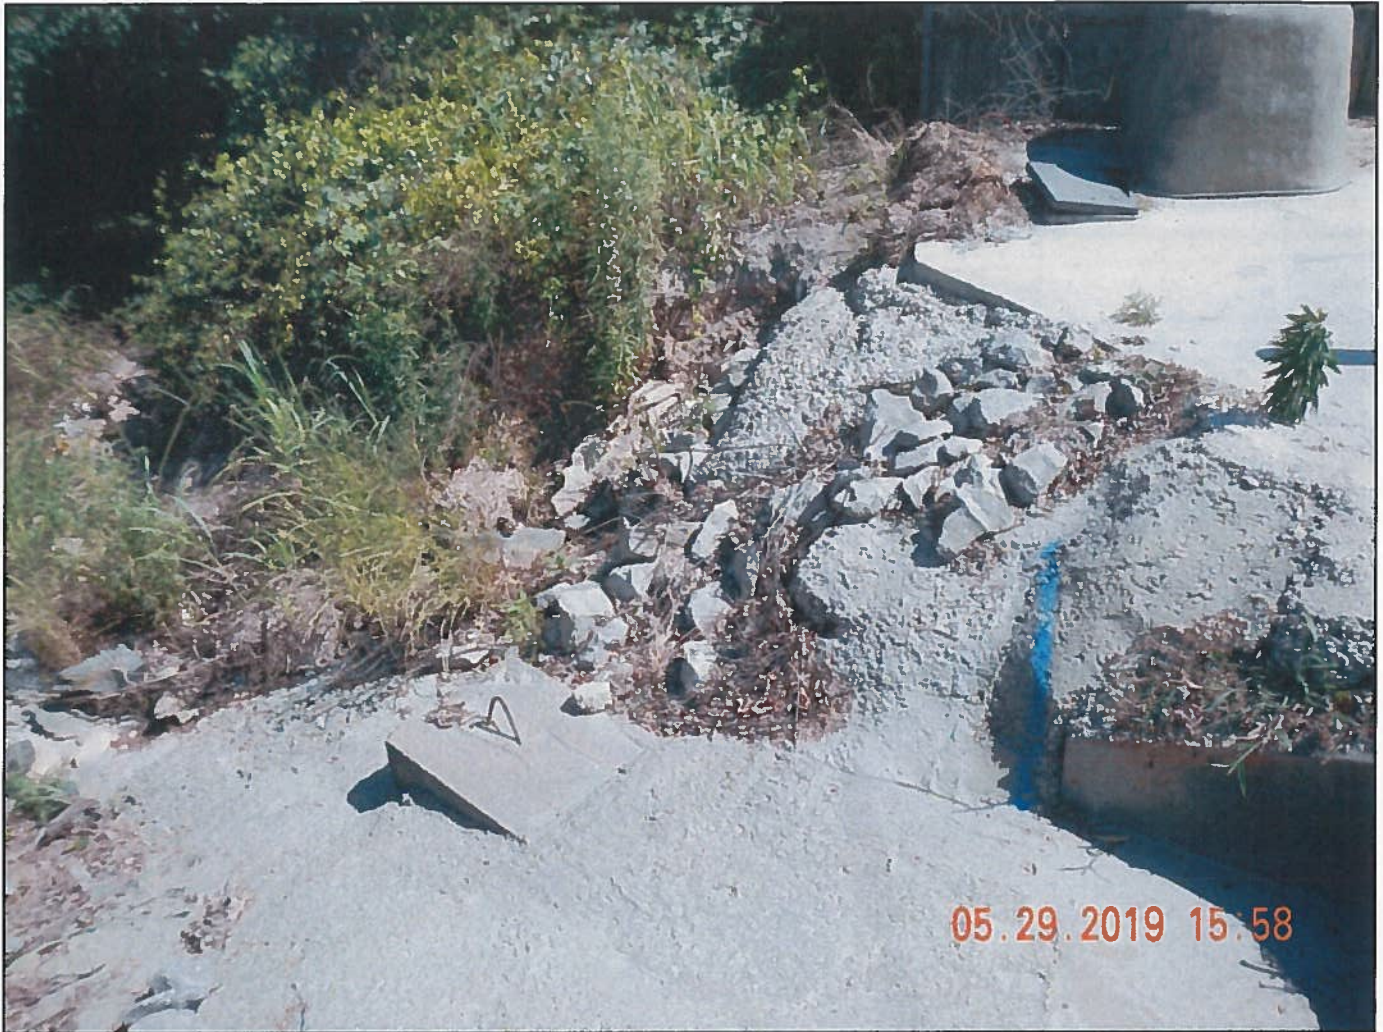
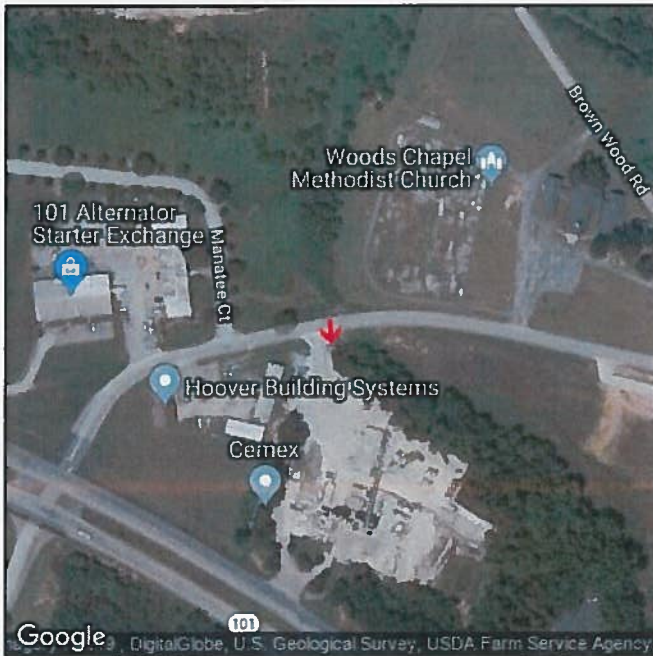
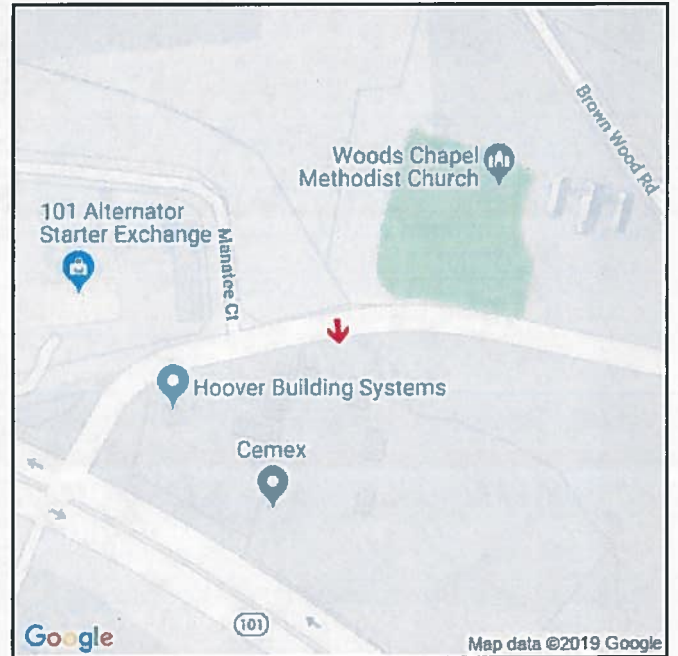
Description	Closer view of outfall 002 area. Samples are grabbed from concrete spillway prior to entry to bottom of ditch about where the blue paint starts. The culvert (bottom right corner) connects to the ditch on the west side of the driveway entrance. Flow from right to left, to upper left.
-------------	---

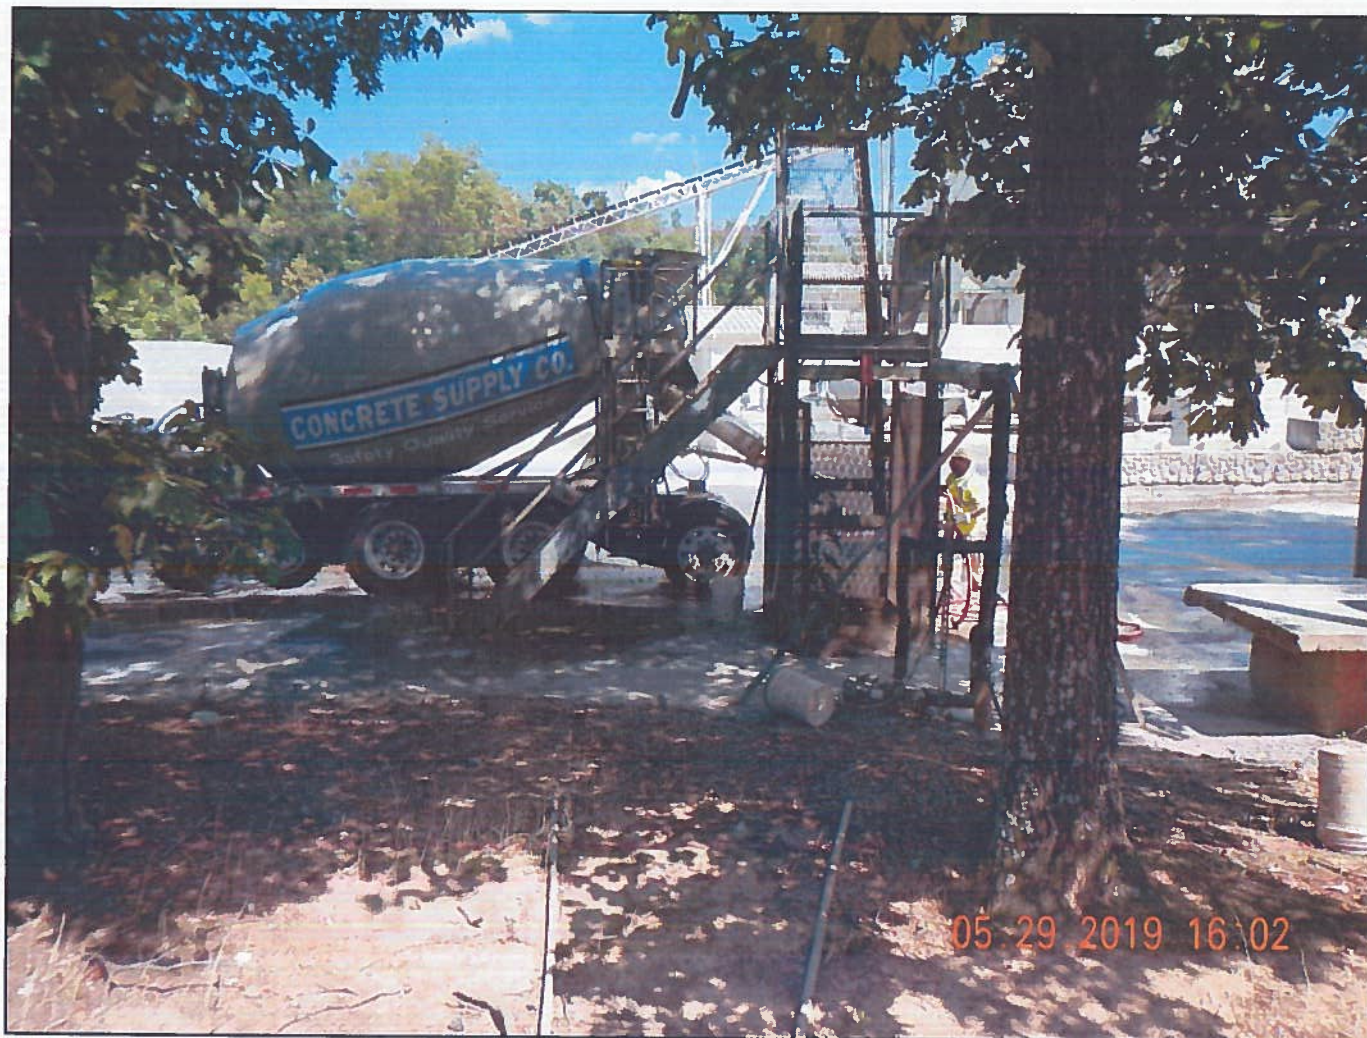
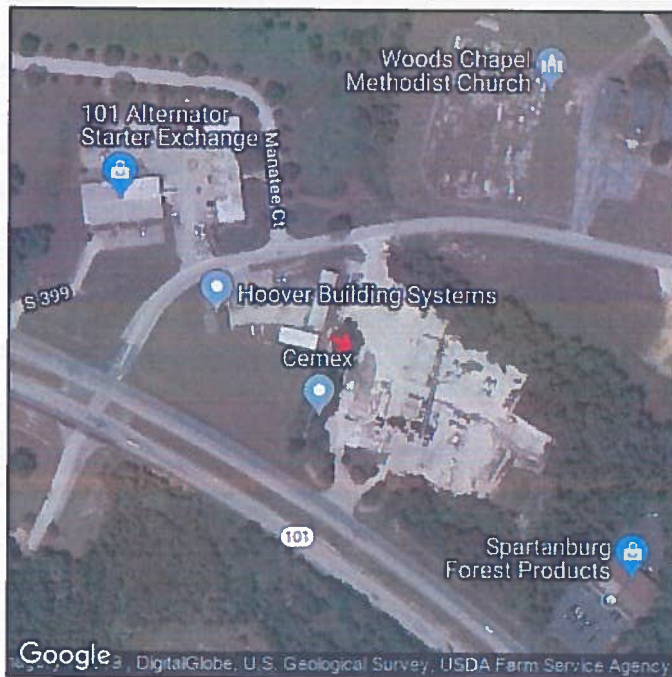
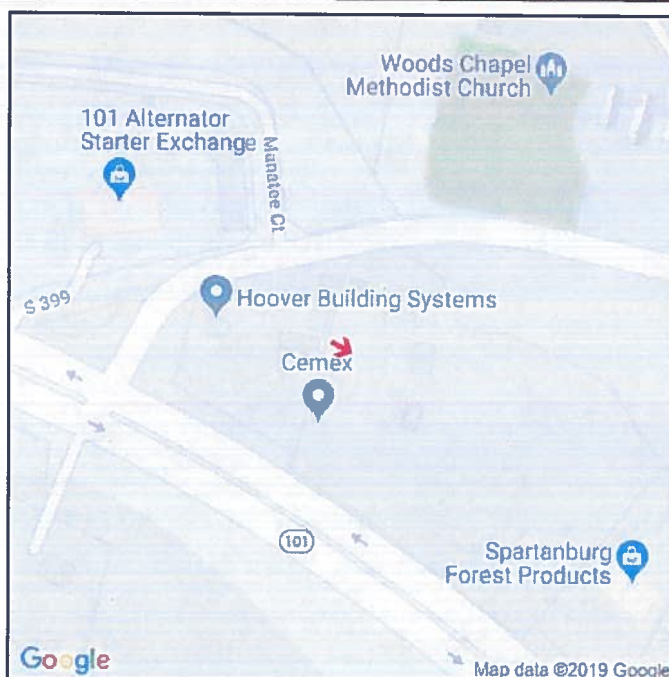
Description	Truck wash station, located about mid-plant, along western border. Looking easterly. Flow heads toward water reuse basin mid-plant. See photo DSCN1789.
-------------	---

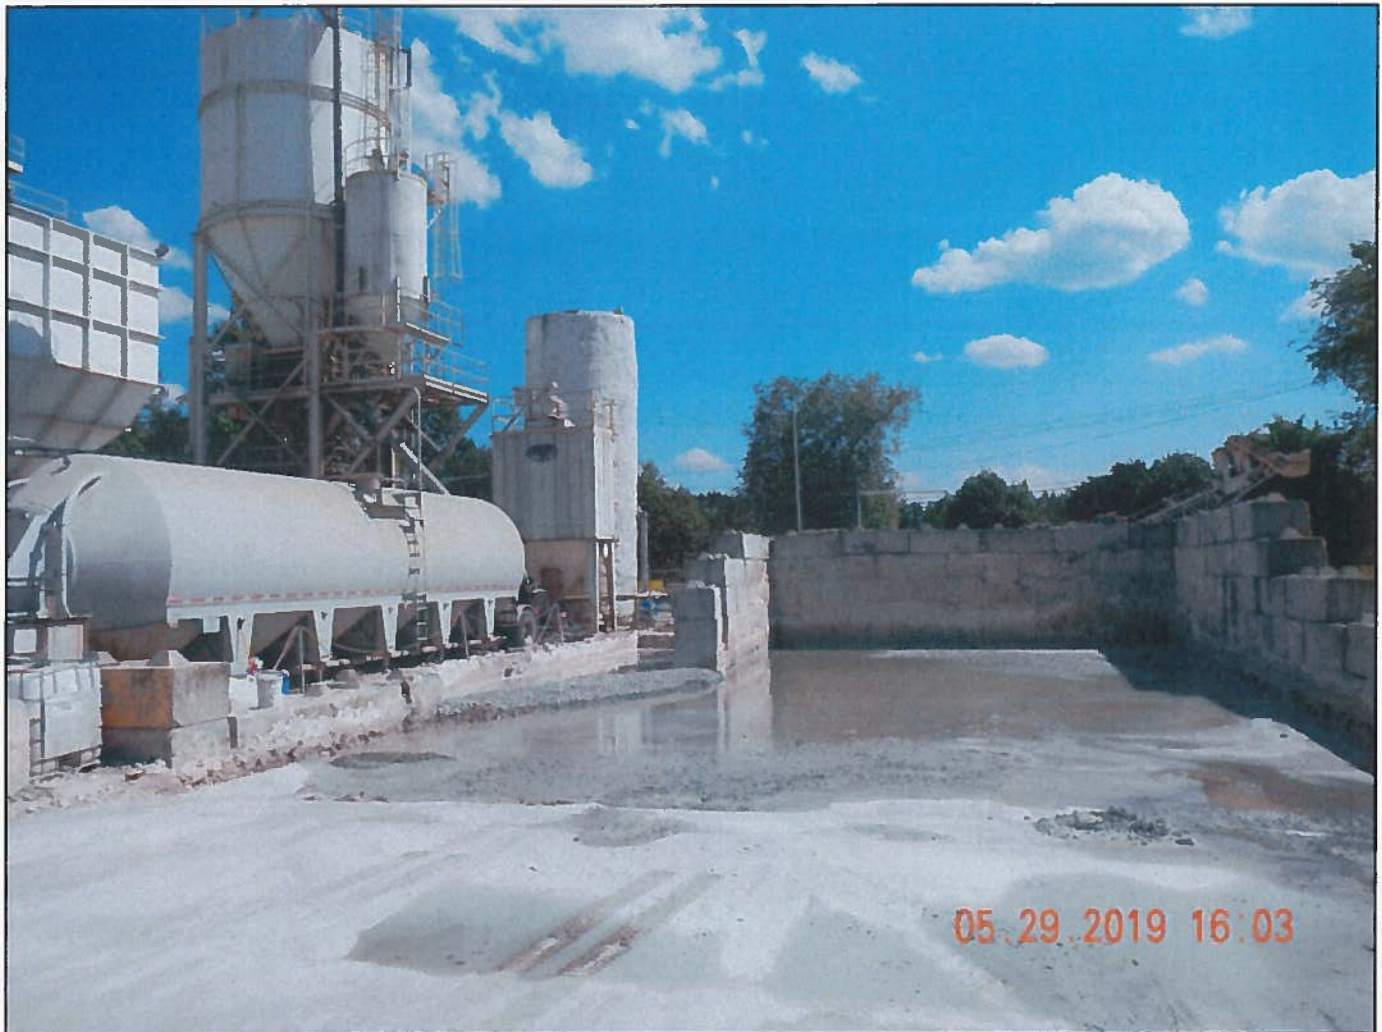
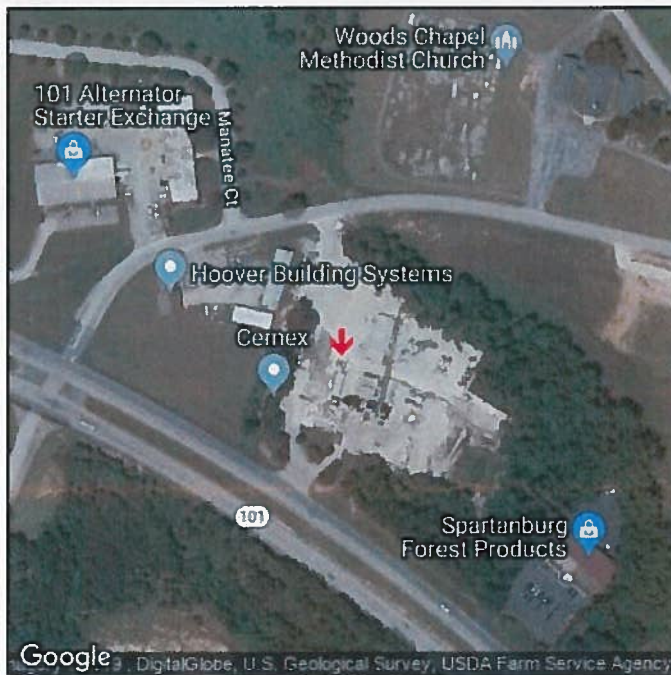
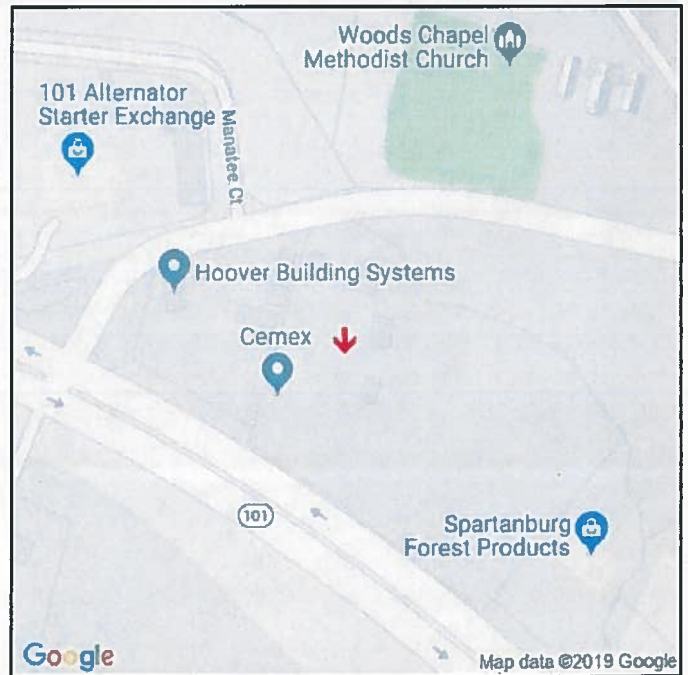
Description	Truck wash water is captured here, flows through a gravel berm center of photo, and is then caught and reused in the concrete mixes as allowed by the concrete recipe.
-------------	--

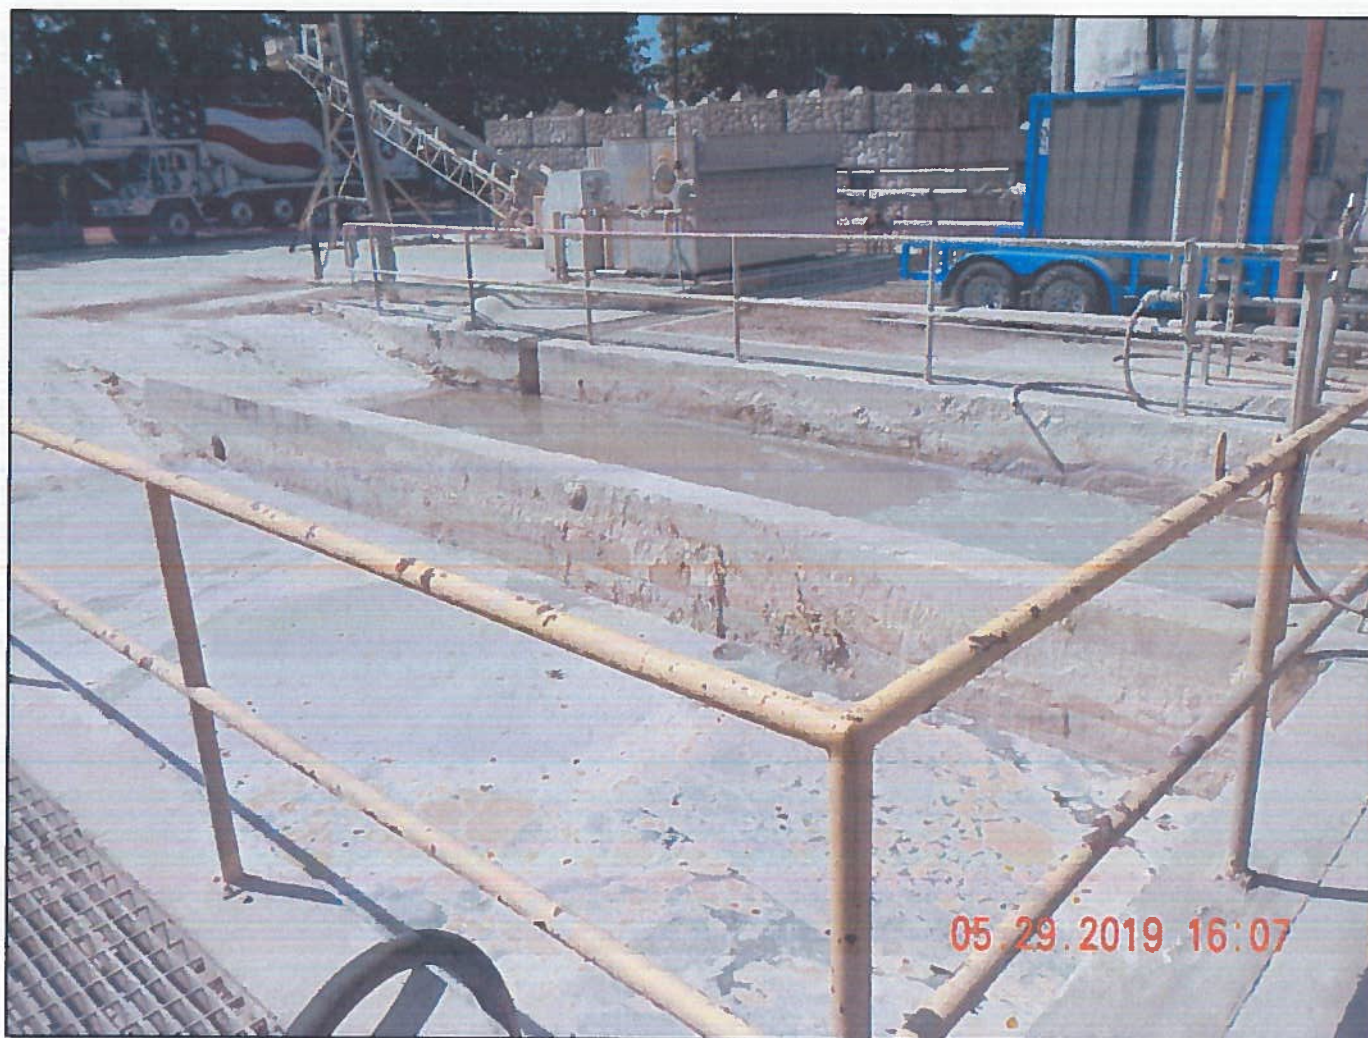
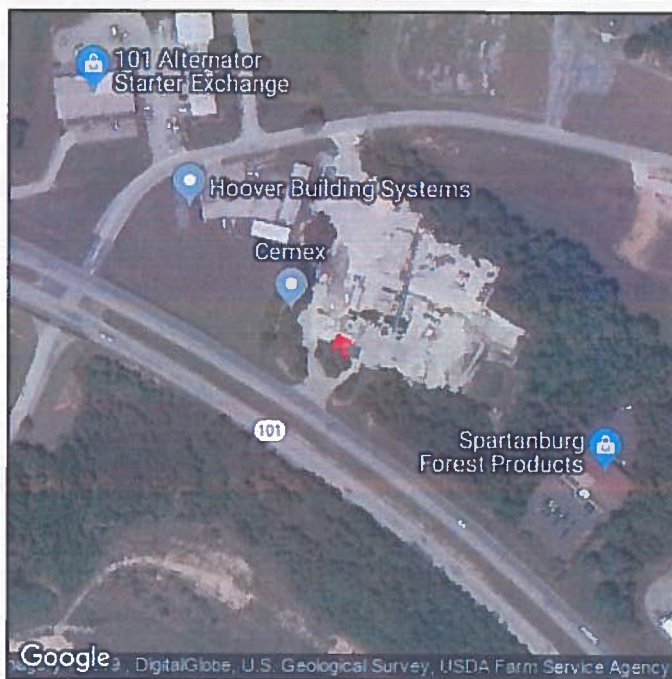
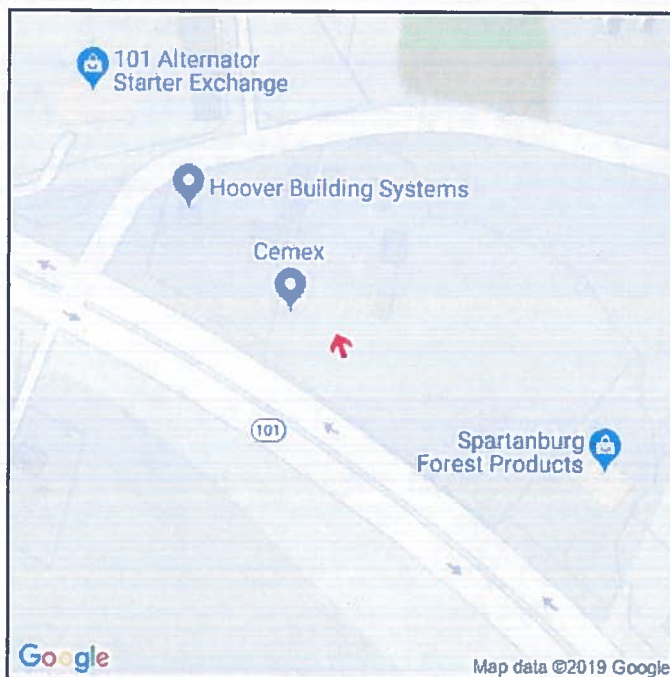
Description	Truck concrete washout water is captured in these two basins, just southwest of the truck loading tower.
-------------	--
